DEPARTMENT OF TRANSPORTATION**DIVISION OF ENGINEERING SERVICES**

Quality Assurance and Source Inspection

Contract #: 04-0120F4Cty: SF/ALA Rte: 80 PM: 13.2/13.9File #: 1.28**WELDING INSPECTION REPORT****Resident Engineer:** Casey, William**Address:** 333 Burma Road**City:** Oakland, CA 94607**Report No:** WIR-028353**Date Inspected:** 08-Sep-2012**Project Name:** SAS Superstructure**OSM Arrival Time:** 700**Prime Contractor:** American Bridge/Fluor Enterprises, a JV**OSM Departure Time:** 2130**Contractor:** American Bridge/Fluor Enterprises, a JV**Location:** jobsite**CWI Name:** Scott Kortum**CWI Present:** Yes No**Inspected CWI report:** Yes No N/A**Rod Oven in Use:** Yes No N/A**Electrode to specification:** Yes No N/A**Weld Procedures Followed:** Yes No N/A**Qualified Welders:** Yes No N/A**Verified Joint Fit-up:** Yes No N/A**Approved Drawings:** Yes No N/A**Approved WPS:** Yes No N/A**Delayed / Cancelled:** Yes No N/A**Bridge No:** 34-0006**Component:** OBG**Summary of Items Observed:**

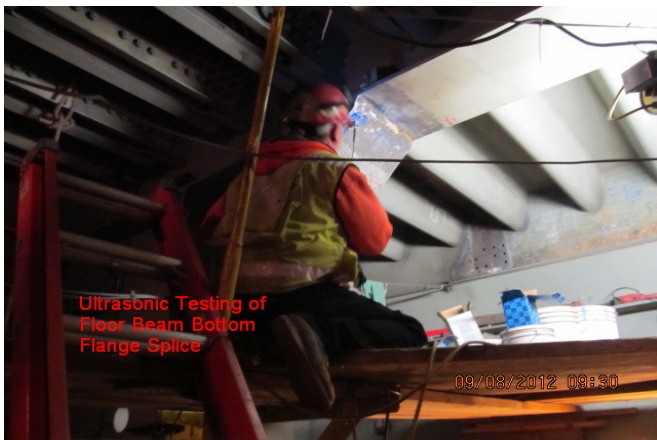
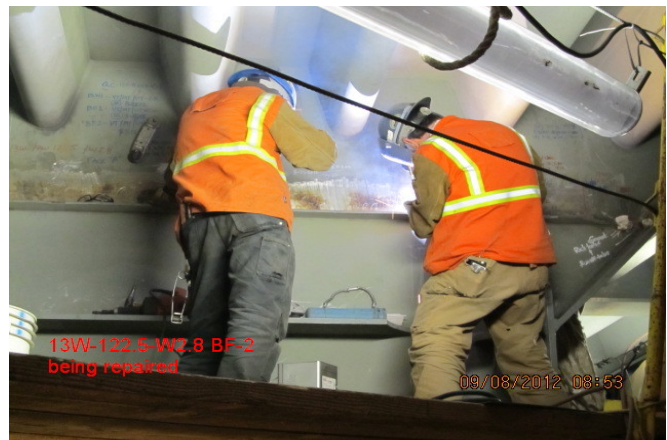
This QA inspector observed critical weld repair being performed (pick up repairs being performed after QC Visual Inspection) by ABF welding personnel Jimmy Zen, without an Engineers approval on Floor Beam Web Splice 13W-PP125.5-W2.8-BF-2, at the following location:

Y= 1500mm, D=7mm, W=15mm, L=1100mm (Face B)

This QA Inspector observed Mr. Zen preheating to a QC recorded, QA verified temperature of 250F prior to using the Carbon Arc Gouging process to remove defects at the above-mentioned locations on the Splice. The locations and depth of the defects had been marked on the steel by the Ultrasonic Technician at the conclusion of his testing. At the end of gouging operations Mr. Zen ground the excavations to a bright clean metal condition in preparation of Visual and Magnetic Particle Testing.
